TWR-64216

Final Postflight Hardware Evaluation Report RSRM-28 (STS-53)

November 1993

This document is the final report for the Clearfield disassembly evaluation and a continuation of the KSC postflight assessment for the RSRM-28 (STS-53) RSRM flight set. All observed hardware conditions were documented on PFORs and are included in Appendices A through C. Appendices D and E contain the measurements and safety factor data for the nozzle and insulation components. This report, along with the KSC Ten-Day Postflight Hardware Evaluation Report (TWR-64215), represents a summary of the RSRM-28 hardware evaluation. The as-flown hardware configuration is documented in TWR-63638. Disassembly evaluation photograph numbers are logged in TWA-1989.

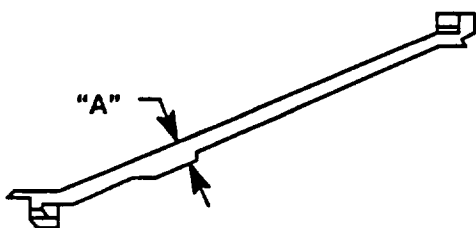
* "A" is the minimum thickness of the bearing protector in-line with the cowl vent holes. It corresponds to the deepest gas impingement location.

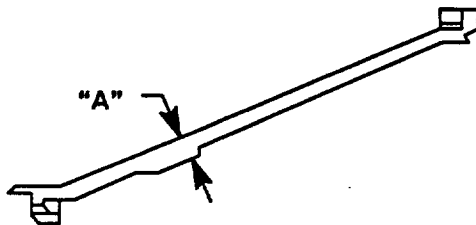
* "A" is the minimum thickness of the bearing protector in-line with the cowl vent holes. It corresponds to the deepest gas impingement location.
